# **A Historical Perspective of the YF-12A Thermal Loads and Structures Program**

Jerald M. Jenkins and Robert D. Quinn

May 1996

National Aeronautics and  
Space Administration

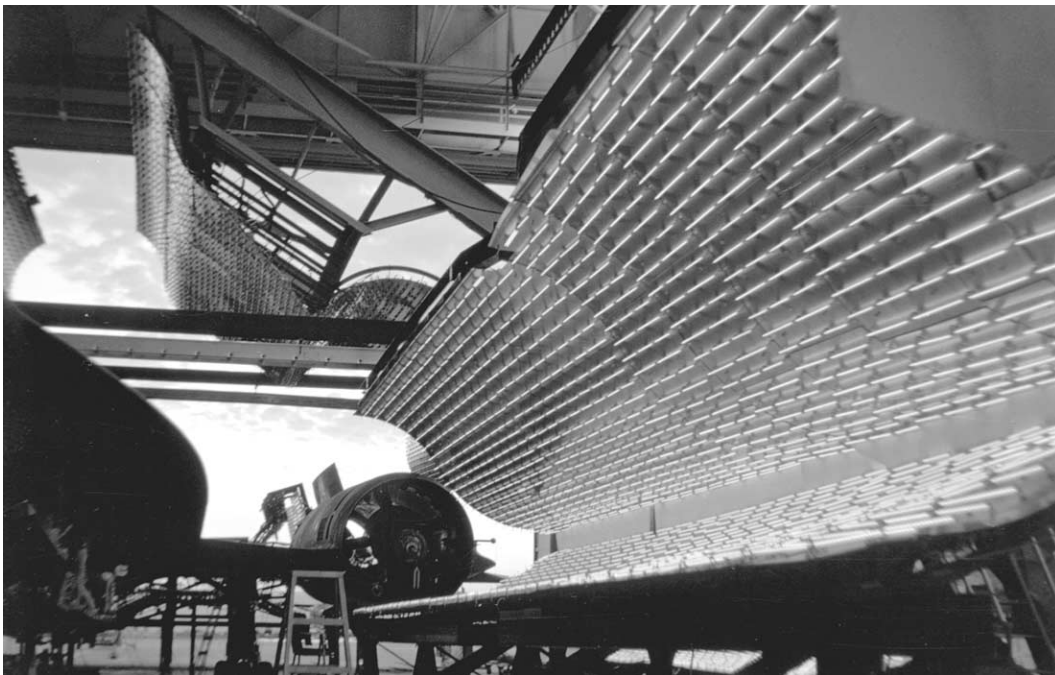
Figure 12. Front heater and upper middle heater in retracted position.

One-half of the forebody heater is shown in the foreground of figure 12 in a retracted position. The background shows the upper middle heaters in the raised position. A somewhat clearer view of the upper

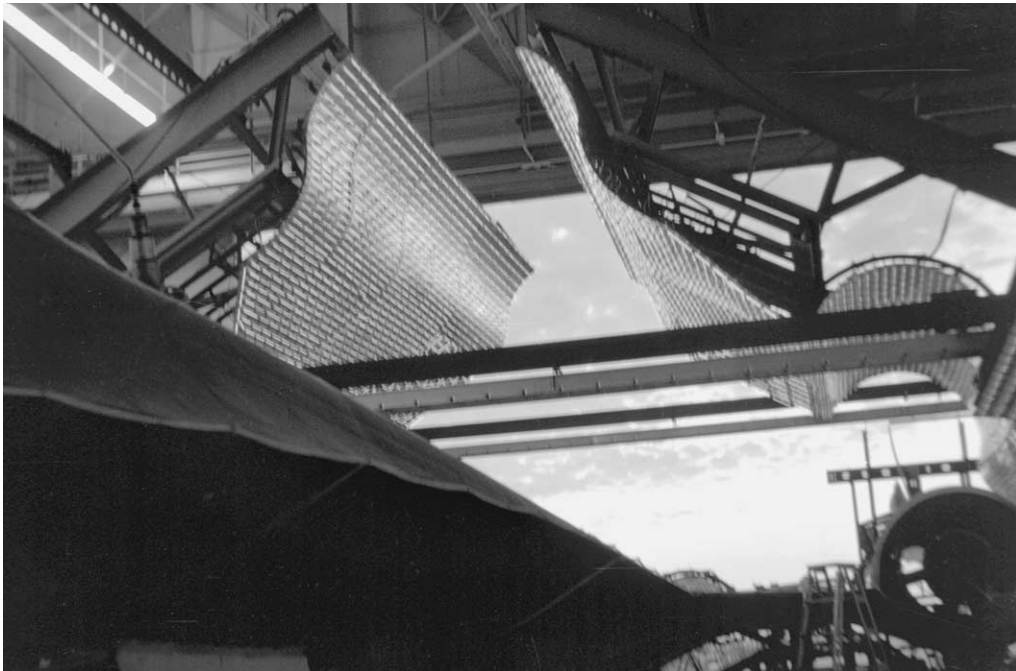
Figure 13. Both sides of the upper middle heater.

middle heater is shown in figure 13. In figures 12 and 13, the lamps are undergoing checkout tests. Figure 14 shows the aft heater in the retracted position. Figure 15 shows the nacelle heater during lamp installation. Figure 16 shows the aft heater and the middle heater in position to heat the airplane. References 13–15 provide an extensive description of the details of the heating and the control of the heating processes.

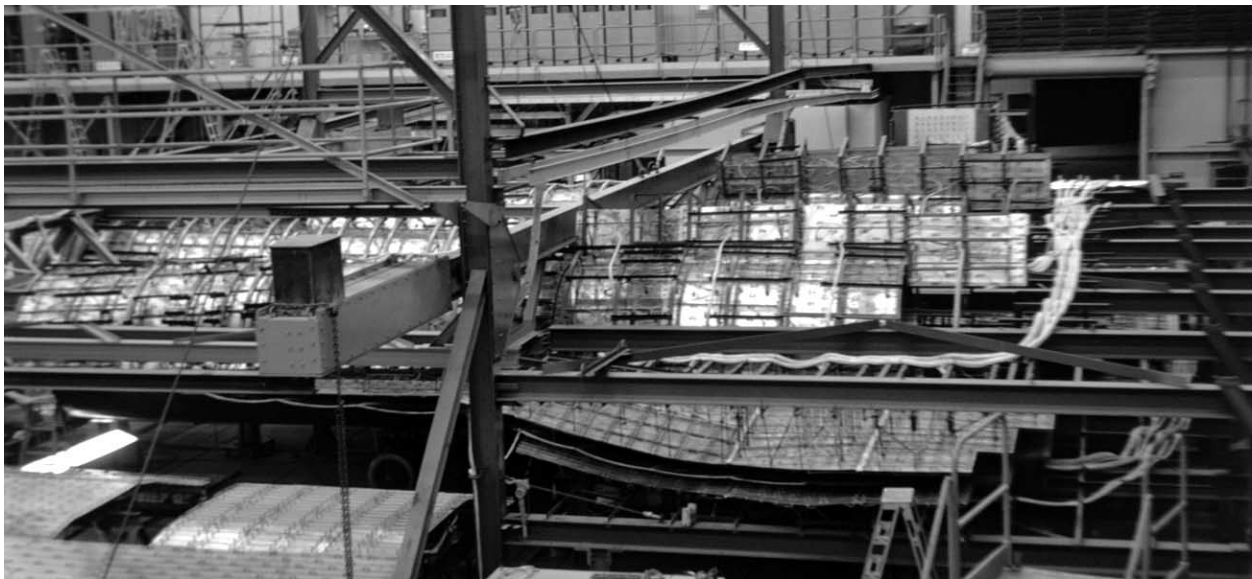
Figure 16. Rear and middle heaters in the aircraft heating position.

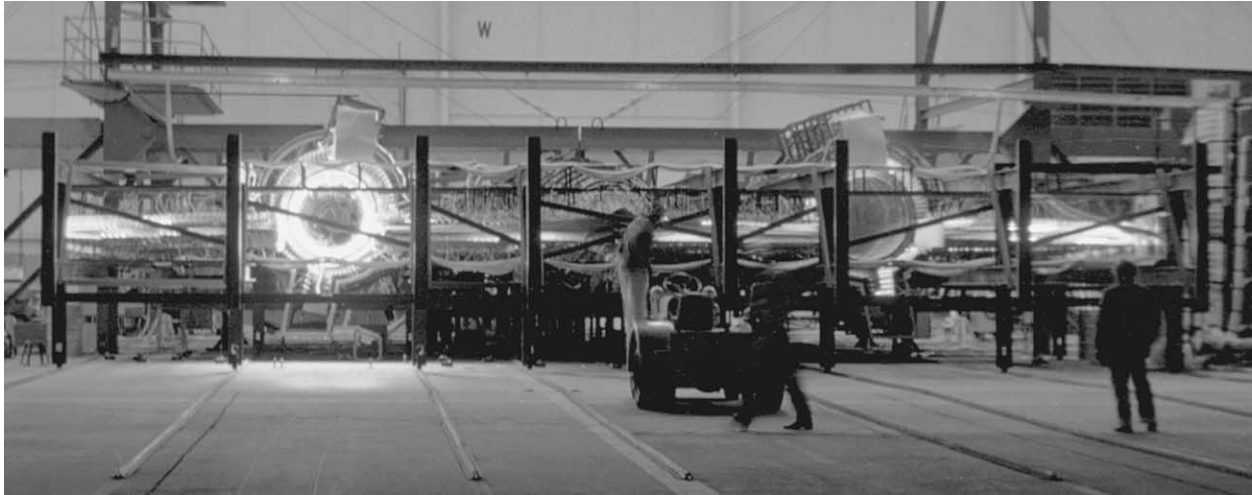
Figure 22. Rear view of YF-12A airplane during a radiant heating test.

Figure 22 shows the heating of the airplane. These tests were conducted late at night because of the anticipated power requirements. The heater system was much more efficient than expected, so the night tests were eventually discontinued, and this work was completed during the daytime.
